This acknowledges receipt of your Defect Information Report submitted June 7, 1996, filed in accordance with 49 CFR Part 573, "Defect and Noncompliance Reports." This recall involves 321,000 Chrysler Corporation (Chrysler) 1991 through 1993 Dodge Caravan, Grand Caravan, Plymouth Voyager, Grand Voyager, and Chrysler Town and Country model vehicles manufactured from July 1990 through June 1993; 1990 through 1993 Dodge Dynasty, Chrysler New Yorker, and Imperial model vehicles manufactured July 1989 through June 1993; and 1991 through 1992 Dodge Monaco and Eagle Premier model vehicles manufactured from July 1990 through June 1992. All of these vehicles are equipped with an antilock braking system (ABS). The ABS hydraulic control unit can experience excessive brake actuator piston seal wear which can cause pump-motor deterioration. If this occurs, the ABS function could be lost and reduced power assist may be experienced during vehicle braking. The assigned ID Number for this recall campaign is 96V-099 (Chrysler Campaign No. 685).

96V-099 (01)

SAFETY RECALL TO TEST AND REPAIR YOUR VEHICLE'S ANTILOCK BRAKE SYSTEM

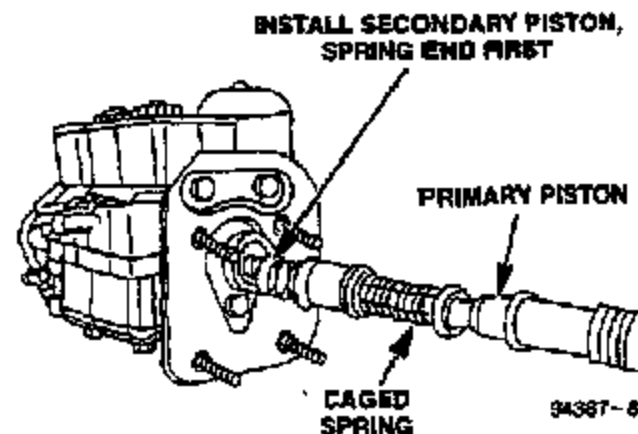
Figure 7

CAUTION: Do not cut, nick or twist any seals or the unit will not function properly.

29. Position the caged spring at the end of the primary piston assembly over the pin on the rear of the secondary piston assembly (Figure 7).
30. Slowly push both piston assemblies into the actuator bore.
