This acknowledges receipt of your Defect Information Report submitted June 7, 1996, filed in accordance with 49 CFR Part 573, "Defect and Noncompliance Reports." This recall involves 321,000 Chrysler Corporation (Chrysler) 1991 through 1993 Dodge Caravan, Grand Caravan, Plymouth Voyager, Grand Voyager, and Chrysler Town and Country model vehicles manufactured from July 1990 through June 1993; 1990 through 1993 Dodge Dynasty, Chrysler New Yorker, and Imperial model vehicles manufactured July 1989 through June 1993; and 1991 through 1992 Dodge Monaco and Eagle Premier model vehicles manufactured from July 1990 through June 1992. All of these vehicles are equipped with an antilock braking system (ABS). The ABS hydraulic control unit can experience excessive brake actuator piston seal wear which can cause pump-motor deterioration. If this occurs, the ABS function could be lost and reduced power assist may be experienced during vehicle braking. The assigned ID Number for this recall campaign is 96V-099 (Chrysler Campaign No. 685).

96V-099 (01)

SAFETY RECALL TO TEST AND REPAIR YOUR VEHICLE'S ANTILOCK BRAKE SYSTEM

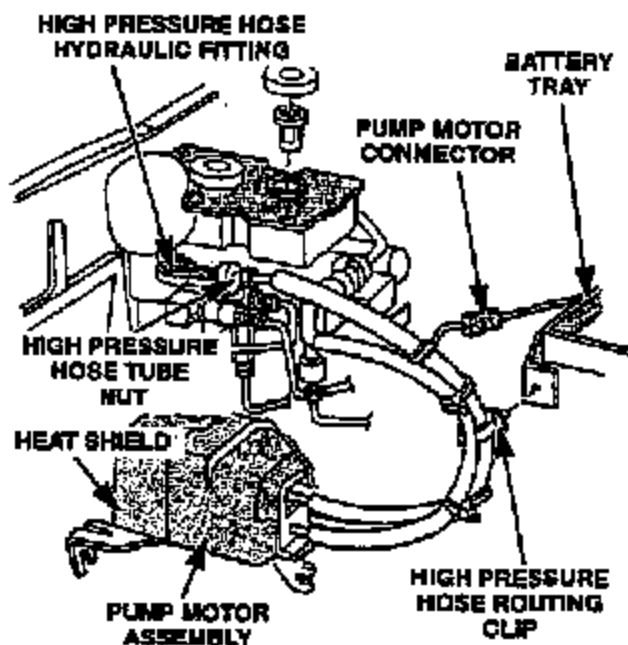
Figure 1

- A. Remove the complete air cleaner assembly.
- B. Locate the high pressure brake fluid hose going from the HCU to the pump/motor (Figure 1). Remove the high pressure hose tube nut from the fitting on the HCU.

- C. Install the test fixture in-line with the high pressure hose (Figures 2 & 3). Screw male end of test fixture into high pressure fitting on HCU and torque to 145 in-lbs (16 N·m).
- D. Install high pressure brake fluid hose into test fixture and torque to 145 in-lbs (16 N·m).
